Applies To: **2000-03 S2000 – ALL**

**February 25, 2003**

## Convertible Top Cover Snap Is Broken

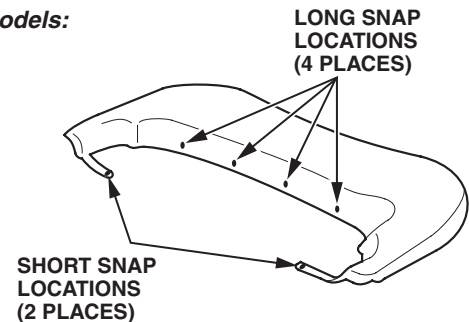
**'00-01 Models:**

1. Inspect the inside of each snap to determine which ones need replacing.
