Applies To: **1998-02 Accord** – ALL
1998-03 Civic – ALL
1999-03 Odyssey – ALL
1998-01 Prelude – ALL
2000-03 S2000 – ALL

Deformed Windshield Molding (Supersedes 00-064, dated May 22, 2001)

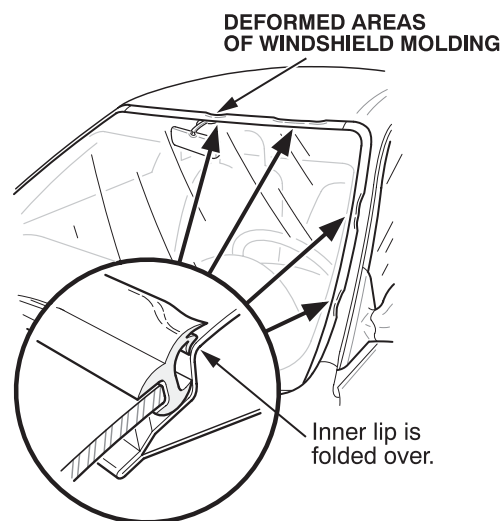
Pull up the outer edge of the windshield molding. Check if the inner lip is folded over anywhere.

- If the inner lip is folded over, go to REPAIR PROCEDURE.
- If the inner lip is not folded, disregard this bulletin, and look for other possible causes.
